**Experimental
Project**
**Control of Eurasian water
milfoil ears in the lake**
Lovering

Progress Report

**Manufacture of canvases and put in
the water**

July 2014

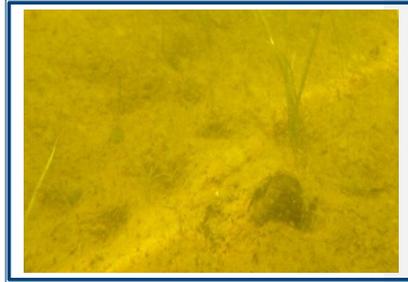
The canvases are in very good condition, however there are several folds inflated. These declines are probably forms during the installation, but it is also possible that the canvases have moved a little because of the waves. A lot of European water milfoil (*Myriophyllum spicatum*) have been crushed under the canvas during the installation, therefore the decomposition of this whole organic matter could create pockets of air and lift the canvases later in the summer.
